# Manhole Inspection Summary

Manhole # S29AA\_007MH

Insp Date: **12/10/07 1:32 PM**

**Location** Address: **625 HOFFMAN ST**

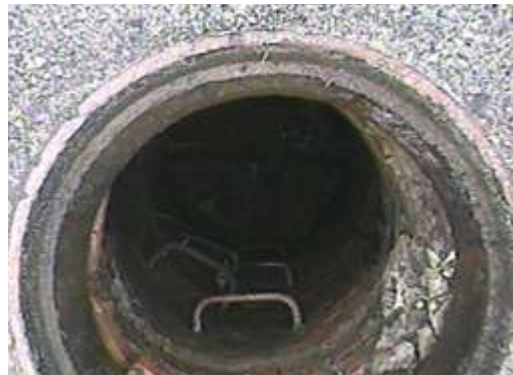
Defect 1

Offset: **5** (in.)

Condition: ☐ Sound ☐ Cracked ☐ Root Intrusion ☒ **Loose Brick** ☒ **Deteriorated**

FRAME OFFSET/ CHIMNEY  
DETERIORATED/LOOSE BRICKS

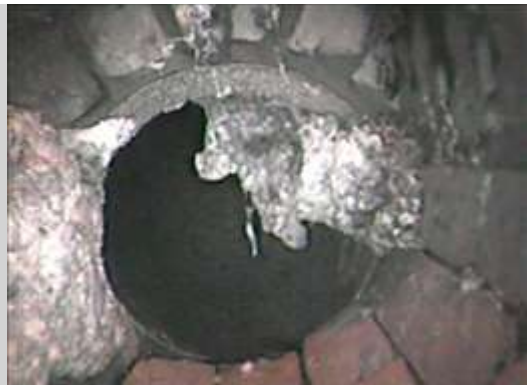
3 O'Clock Inflow

UNKNOWN SUBSTANCE ON PIPE
